Restoring Efficient Irrigation through Channel Rehabilitation in Village Taimoor Khan

Case Study

Rehabilitation of Irrigation Water Channel

Under the project: *“Building Resilience through Improved Food and Nutrition Security in KP, Punjab, and Balochistan.”*

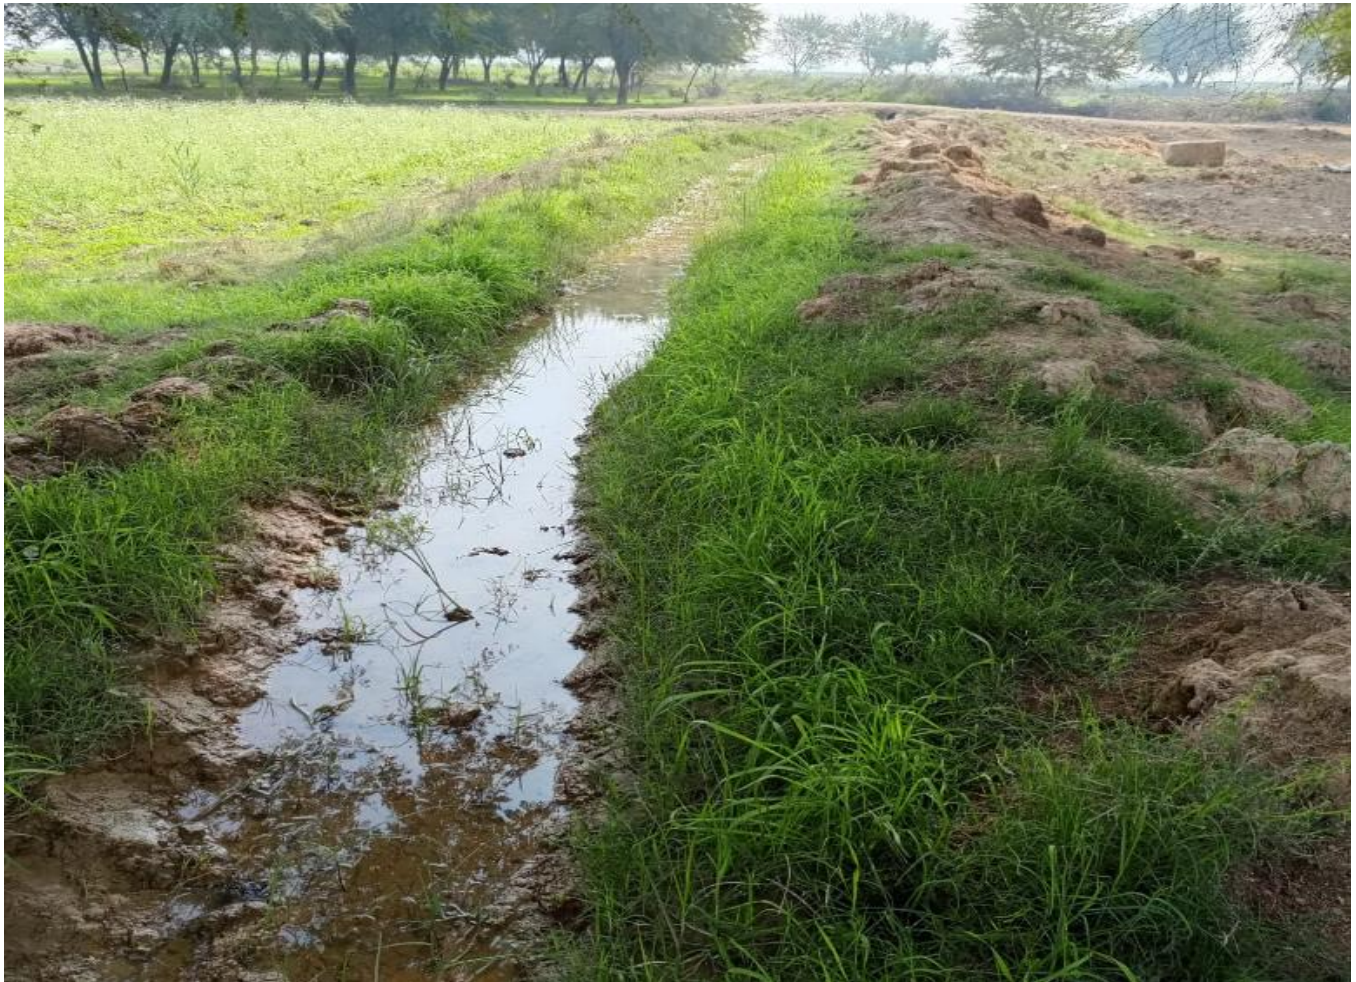
Village Taimoor Khan in District Jhal Magsi relies heavily on agriculture for both income and food security. However, the community faced persistent irrigation challenges due to a deteriorated, unlined water channel connecting the local canal to the farmland. Years of soil erosion, seepage, and uneven channel surfaces resulted in nearly **50% water loss** before reaching the fields. This inefficiency reduced crop yields and intensified disputes over water distribution especially for tail-end farmers who often received little to no water. In a region already prone to drought and water scarcity, these challenges threatened the sustainability of agricultural livelihoods.

To address these issues, Human Organization for peaceful Environment-**HOPE**, in partnership with Welthungerhilfe (WHH) and the Norwegian Ministry of Foreign Affairs, rehabilitated 800 running feet (rft) of the irrigation channel.

- Excavation and reshaping of the damaged earthen channel
- Lining the channel with Plain Cement Concrete (PCC) to prevent seepage
- Improving water flow efficiency and minimizing losses
- Providing farmers with basic training on channel maintenance, water regulation, and equitable distribution

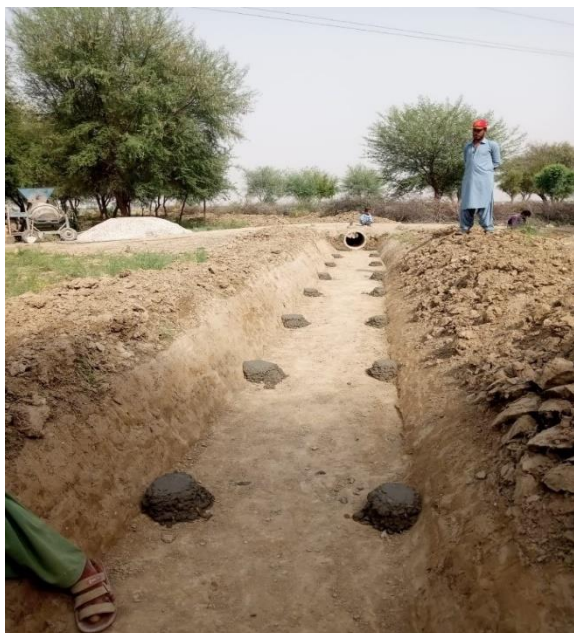
Key Technical Summary

Sr. No	Channel Description	Details
1	Length	800 RFT
2	Water Wastage Reduced	74 cubic meters / 74,404 liters
3	Irrigation Capacity	68 acres
4	Farmers / Households Benefited	43
